# Manhole Inspection Summary

# Manhole # S33EE1003MH

Insp Date: **3/10/07 9:33 AM**

**Location** Address: **3805 39TH ST**

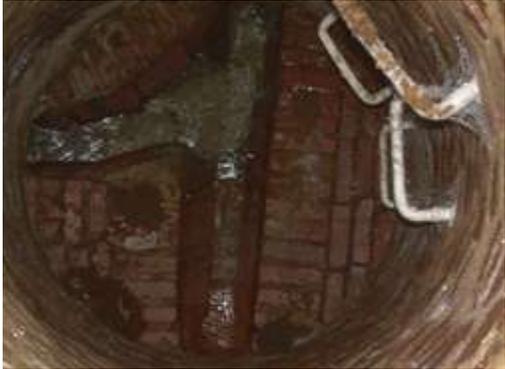
Top View

Evidence of surcharge - Bench debris.

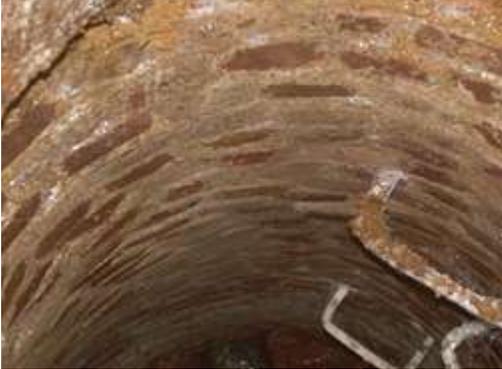
Defect

Frame leaks. Corbel infiltration.

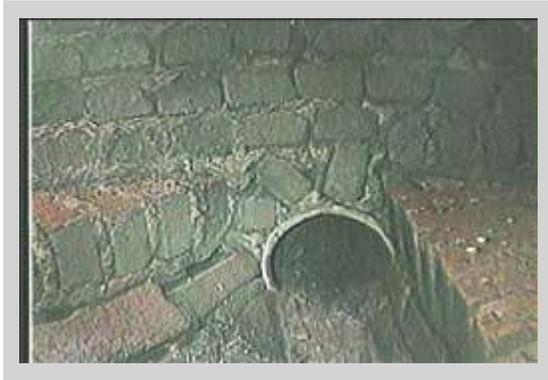
**8 in. Circular Gravity Sewer  
Pipe Out @ 12 O'Clock**

Barrel deterioration and infiltration. Channel deterioration.

Infiltration: **Evidence** Pipe Seal Cond: **Cracked**

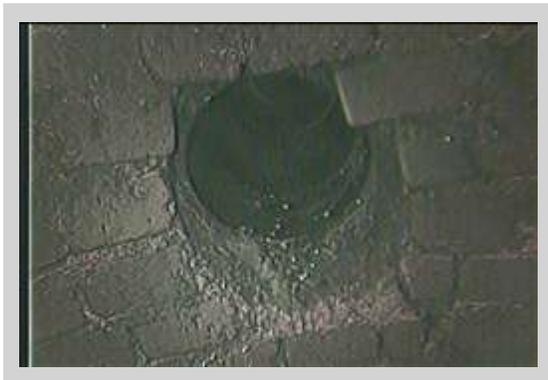
**8 in. Circular Gravity Sewer  
Pipe In @ 6 O'Clock**

Infiltration: **Evidence** Pipe Seal Cond: **Cracked**

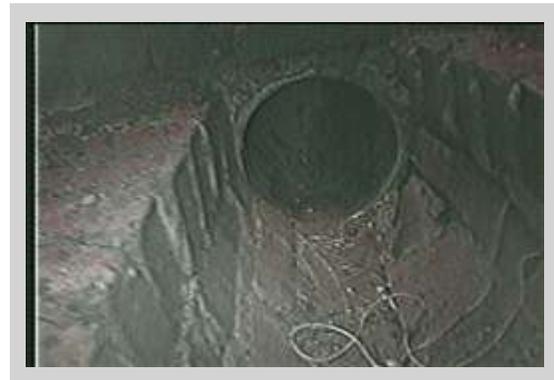
**Drop In @ 6 O'Clock**

Barrel deterioration and infiltration. Channel deterioration.

Drop: **Outside Rod and Bar**  
Angled: **Yes** Reading: **10.15** (ft.)  
Inv Depth: **11.15** (ft.)  
Drop Condition: **Open**
